# A Natural Resource Condition Assessment for Sequoia and Kings Canyon National Parks

## *Appendix 3 – Erosion and Mass Wasting*

Natural Resource Report NPS/SEKI/ NRR—2013/665.3

John T. Austin  
Sequoia and Kings Canyon National Parks  
47050 Generals Highway  
Three Rivers, CA 93271

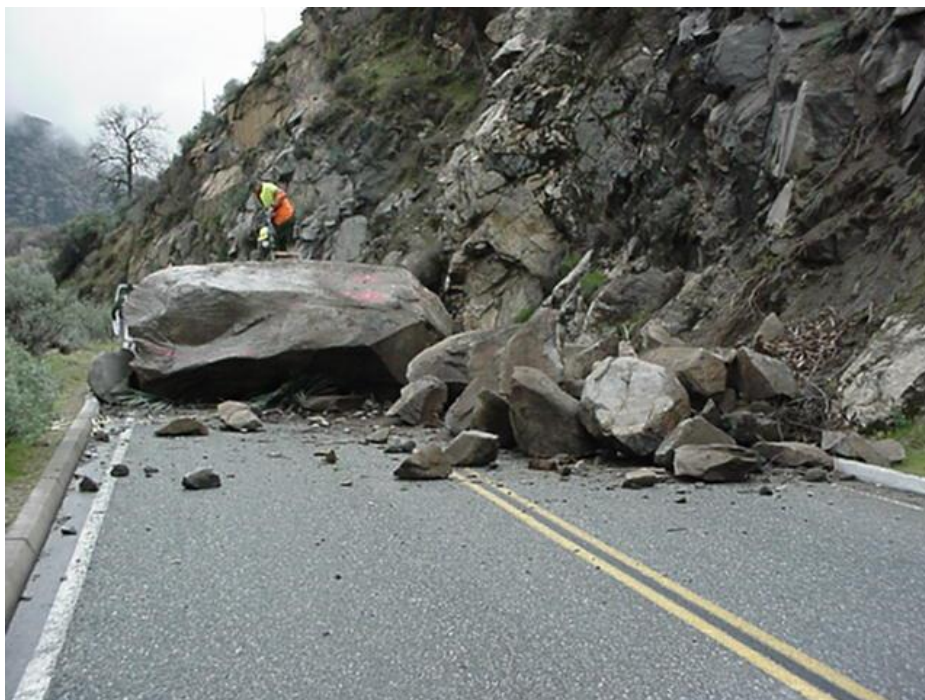
**Figure 1.** Rock fall about a mile below Tunnel Rock, January 28 2005.

We notice individual big rocks more when they come down in the frontcountry. For example, the rock that fell on the Generals Highway in 2005 was big enough to block the entire road all by itself.

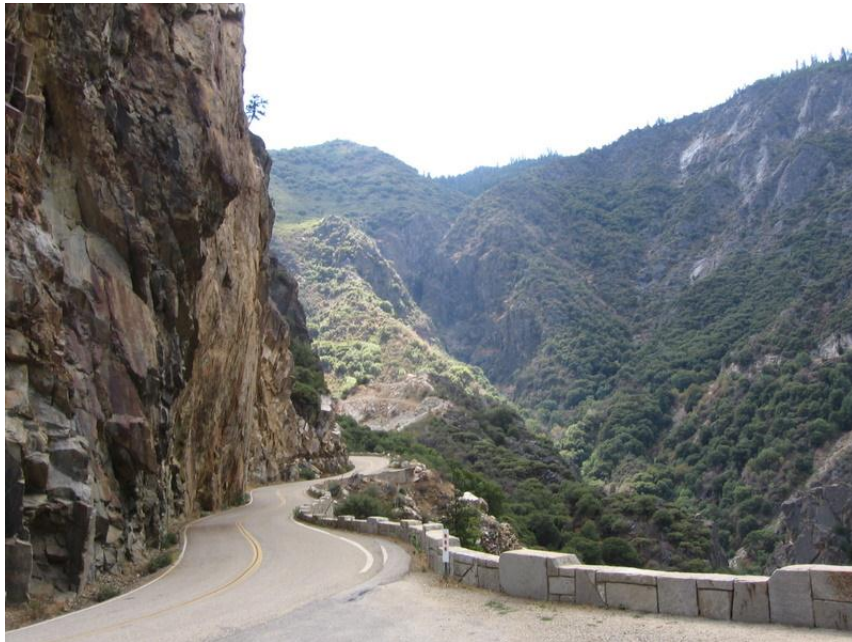
**Figure 2.** Cliff-side road in Kings Canyon.
